The following pictures show the tests that I did with three ST1 detectors bump bonded to FPIX1 chips. All the tests were performed in a time window smaller then 1 hour, so it's unlikely that the temperature factor would be important in the comparison between detectors.

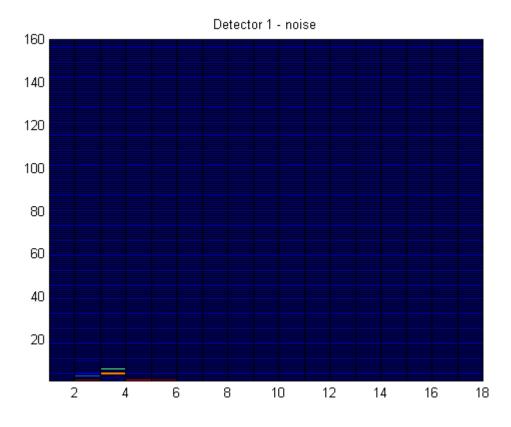
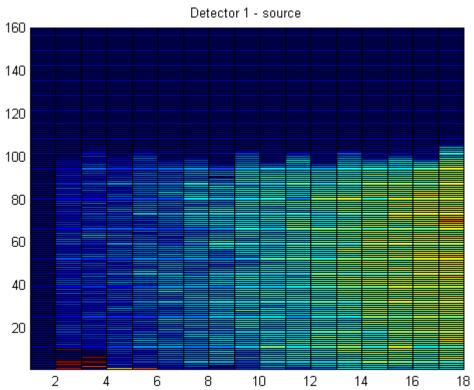
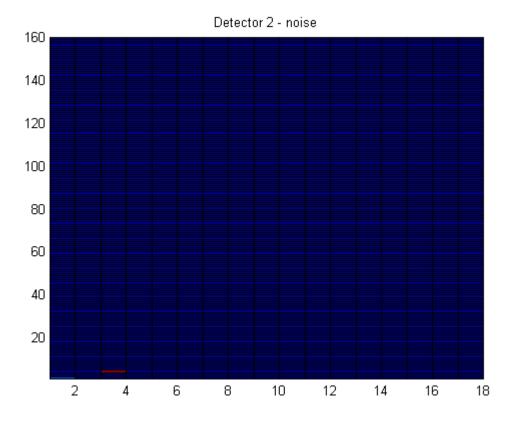
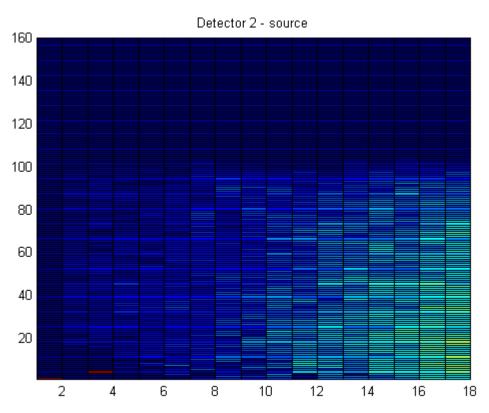
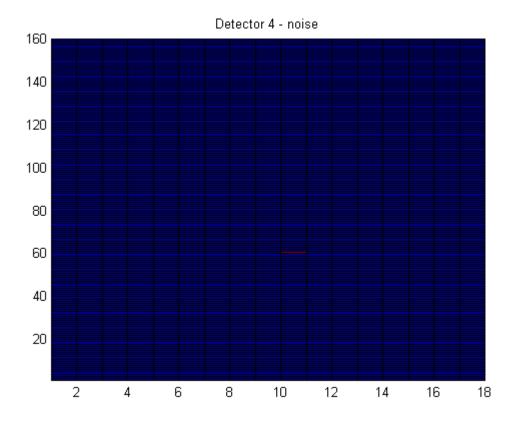
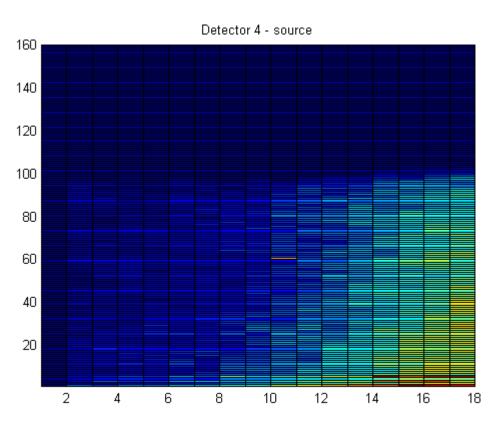
Test conditions:

- Threshold: Vth0 = 2.05V
- High voltage bias: Vb = -75V
- Bias current:
  - Detector 1 : -18.2nA;
  - Detector 2 : -23nA
  - Detector 4 : -45.2nA

All the tests (noise and source) were performed doing the readout of the chip  $10,\!000$  times, using a pattern generator as a trigger. The time interval of this trigger is  $968\mu s$ .

The noise test was done without the injection of any kind in the chip. The inject\_charge input was connected to ground using a termination of  $50\Omega$ .

The source test was done with a  $\gamma$  radioactive source about 1.5 cm of the sensor.

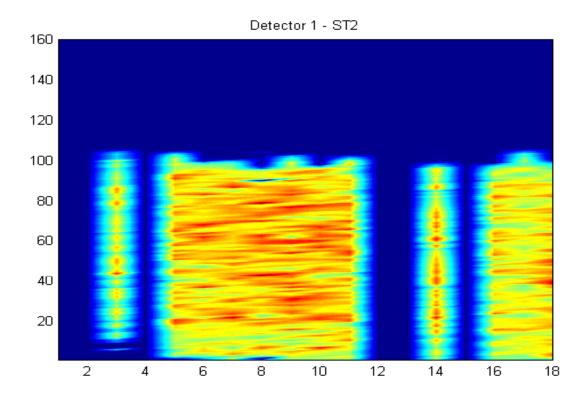
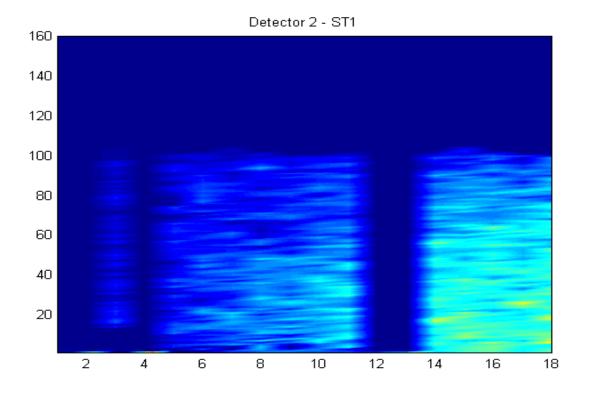
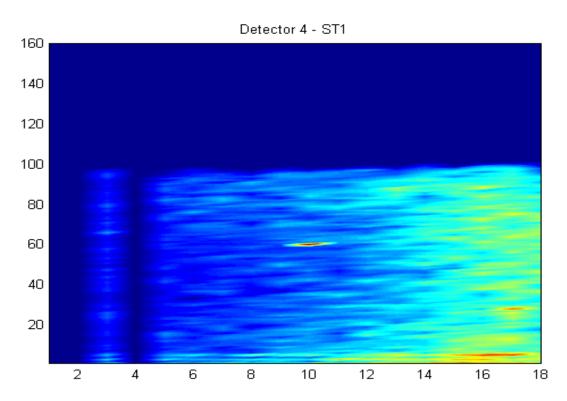
One very interesting result was find in the beginning of these tests. In this period the chip was not being initialized with the mask registers. By the design it is something that could be done, but the reset of the chip should be enough to leave the chip in a known condition. But the results found show us that the initialization of these mask registers is fundamental to have the chip working properly. If this is not done, some of the columns just don't readout at all.

The following pictures show how the readout looks like when this is the case. The tests were done using the same procedures as explained before, with the same values in the power supplies.
